PERATION

GREENHOUSE

SCIENTIFIC DIRECTOR'S REPORT

ANNEX 3.2 U. S. NAVY STRUCTURES

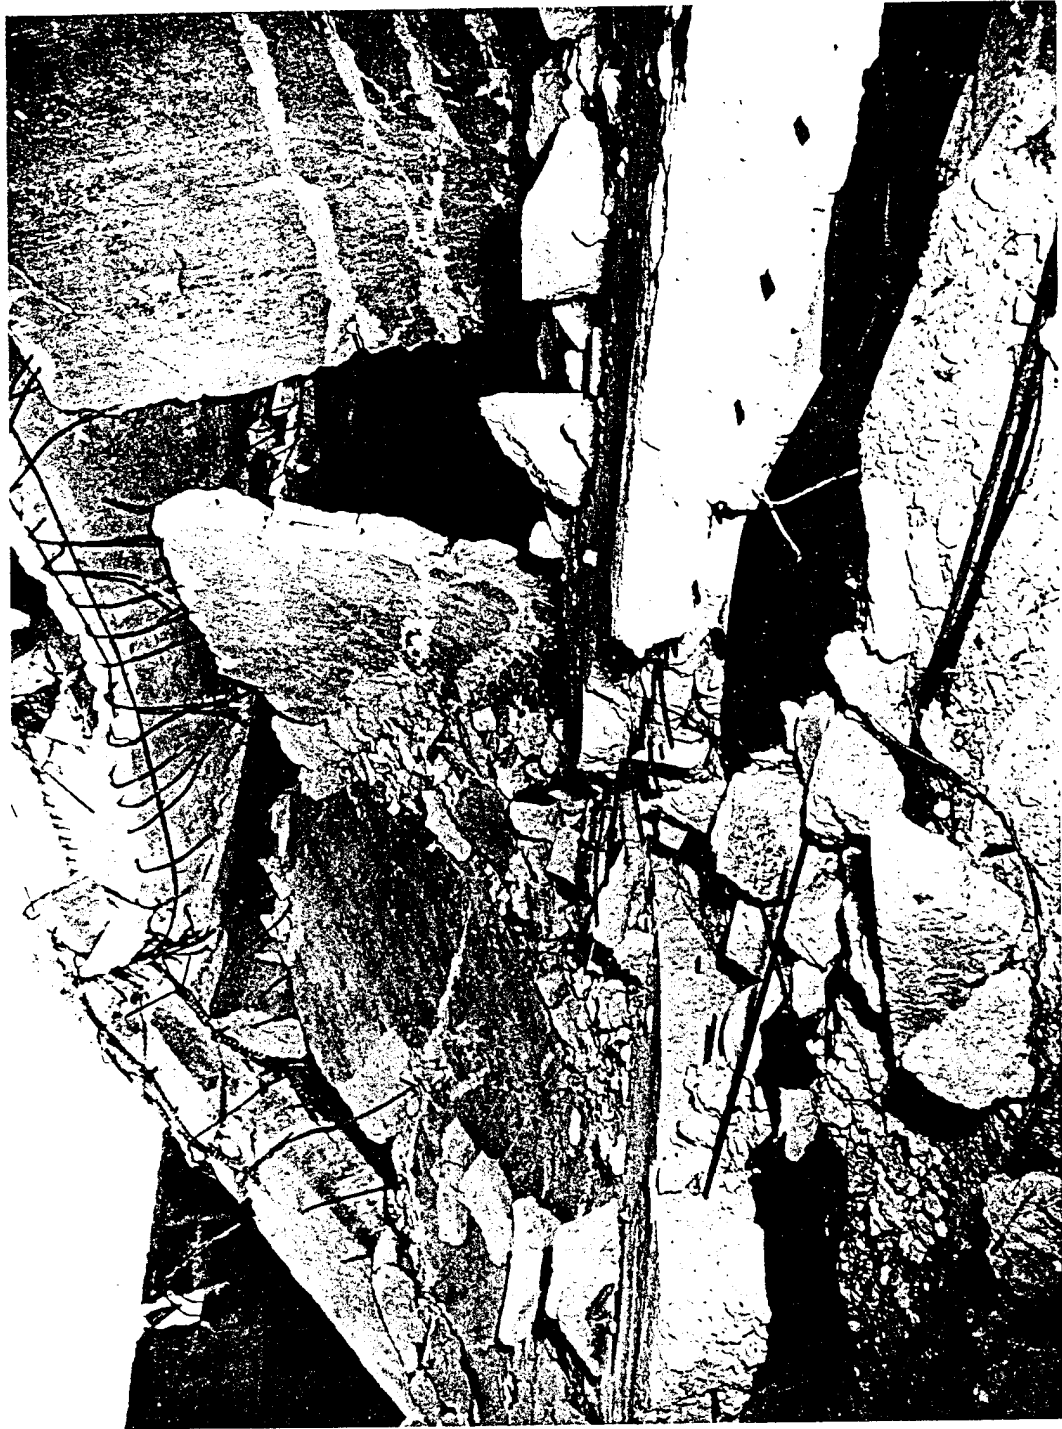
Fig. L. 467 Steel Dowels to Foundation Were Necked Down Indicating Tension Failure, Structure 3.2.7a

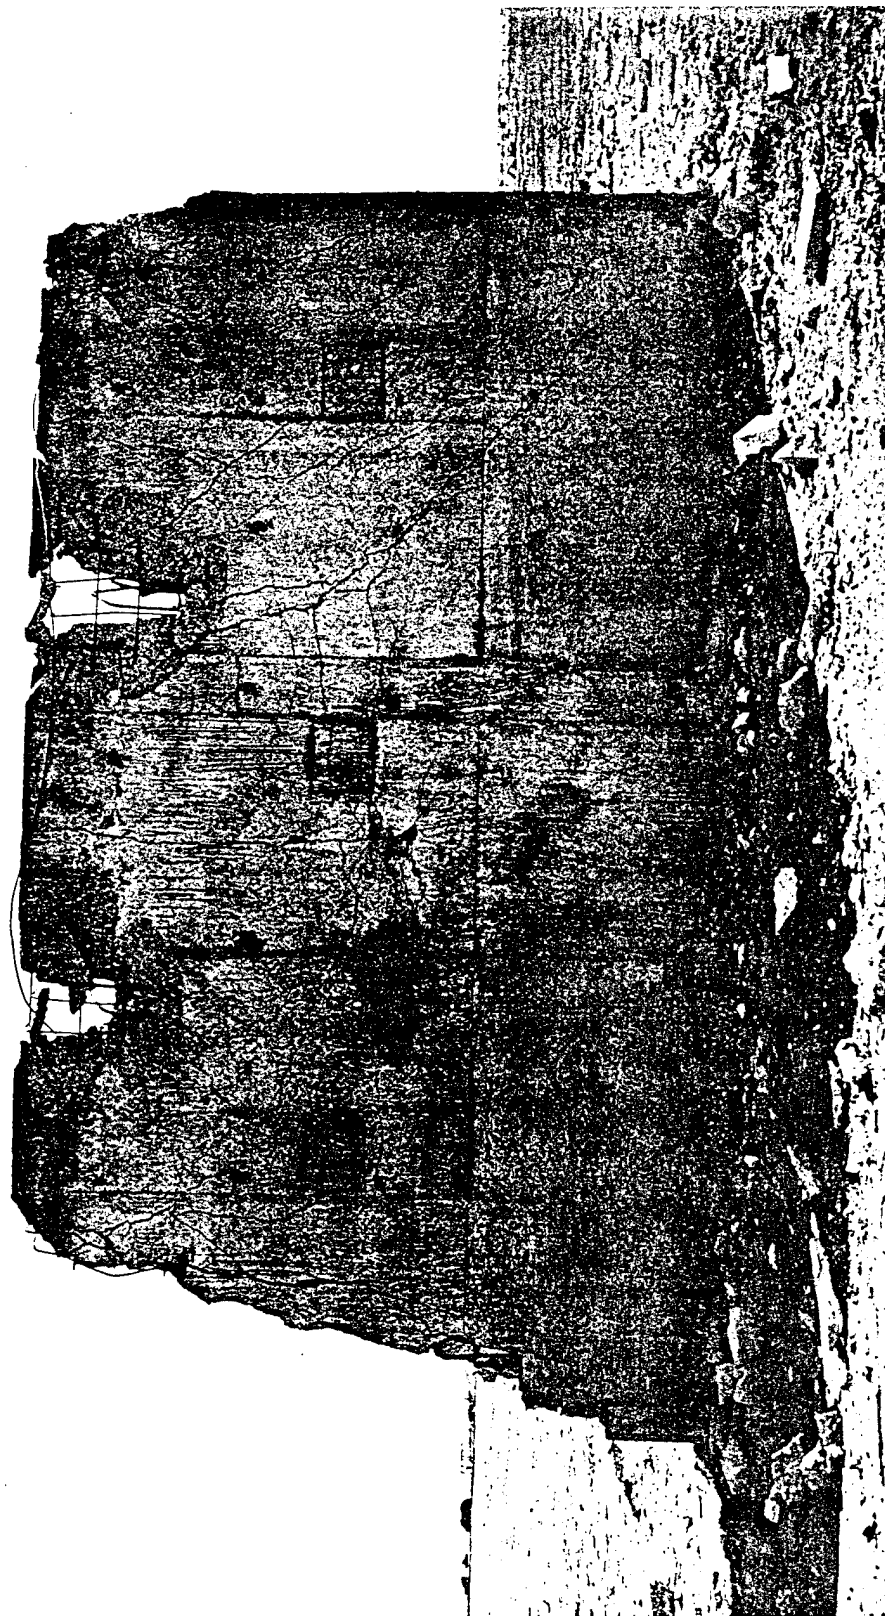
Fig. L.468 Right End Wall, Structure 3.2.7a. The two stringer haunches stayed with the roof, leaving the holes at top edge.

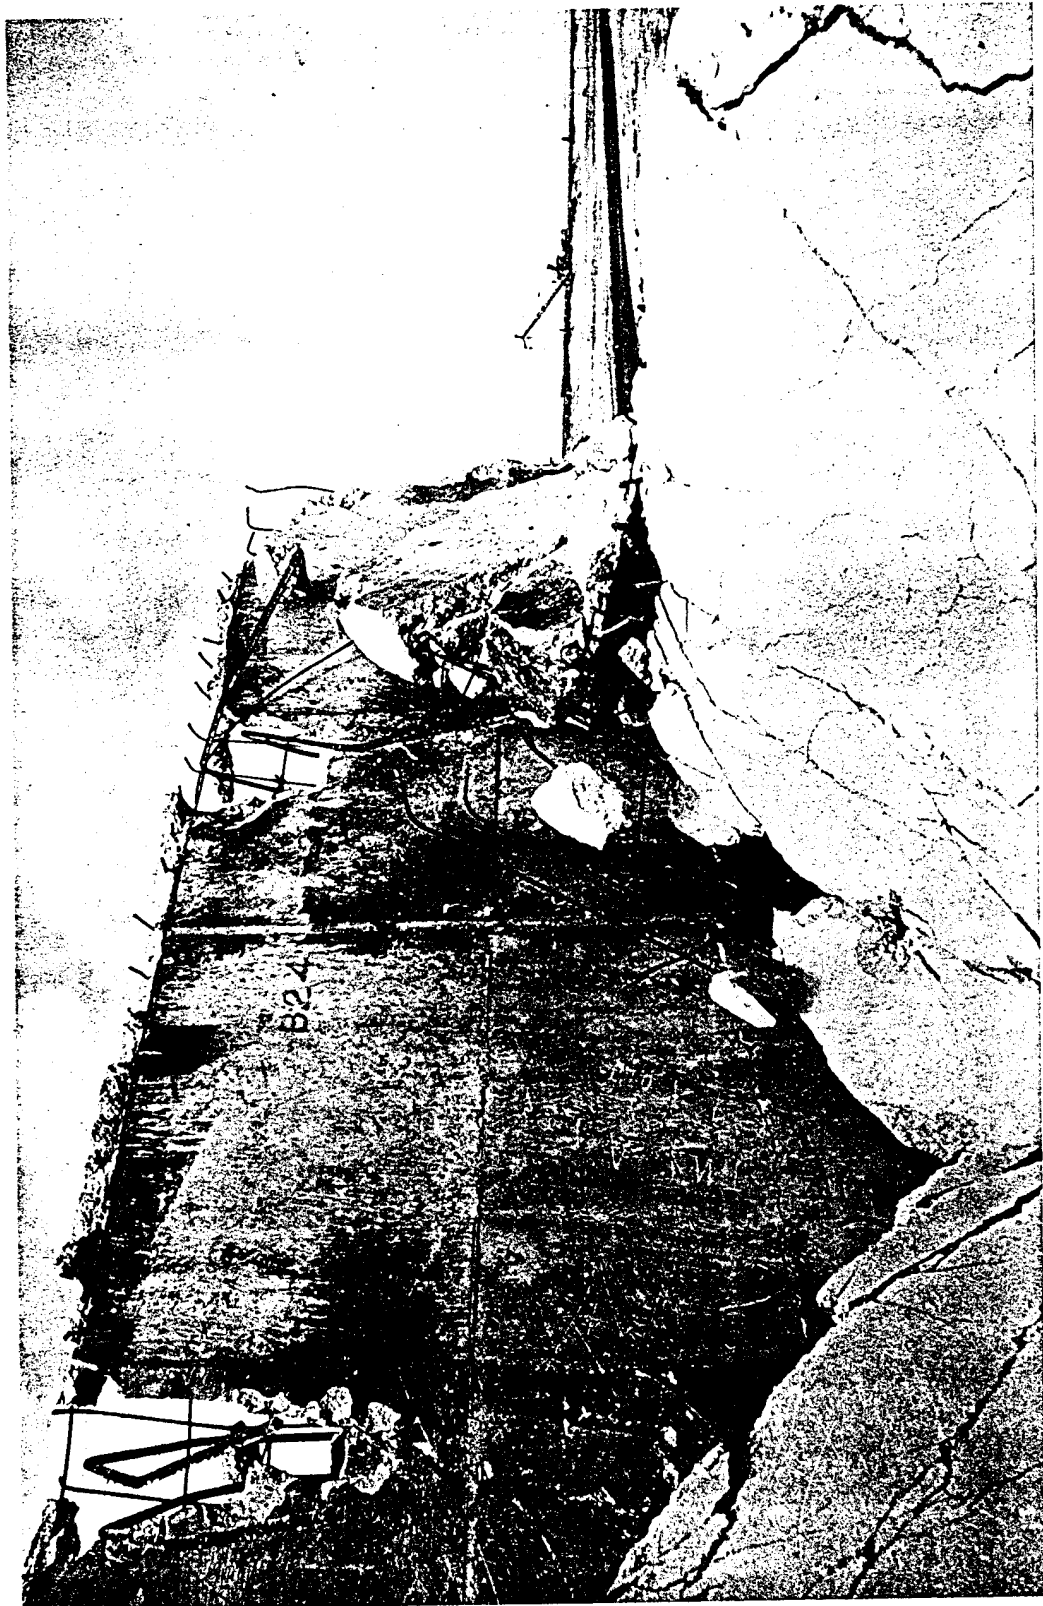
Fig. L. 469 Interior View of Right End Wall, Structure 3.2. 7a. Note top tension bars of stringers remained with the end walls.

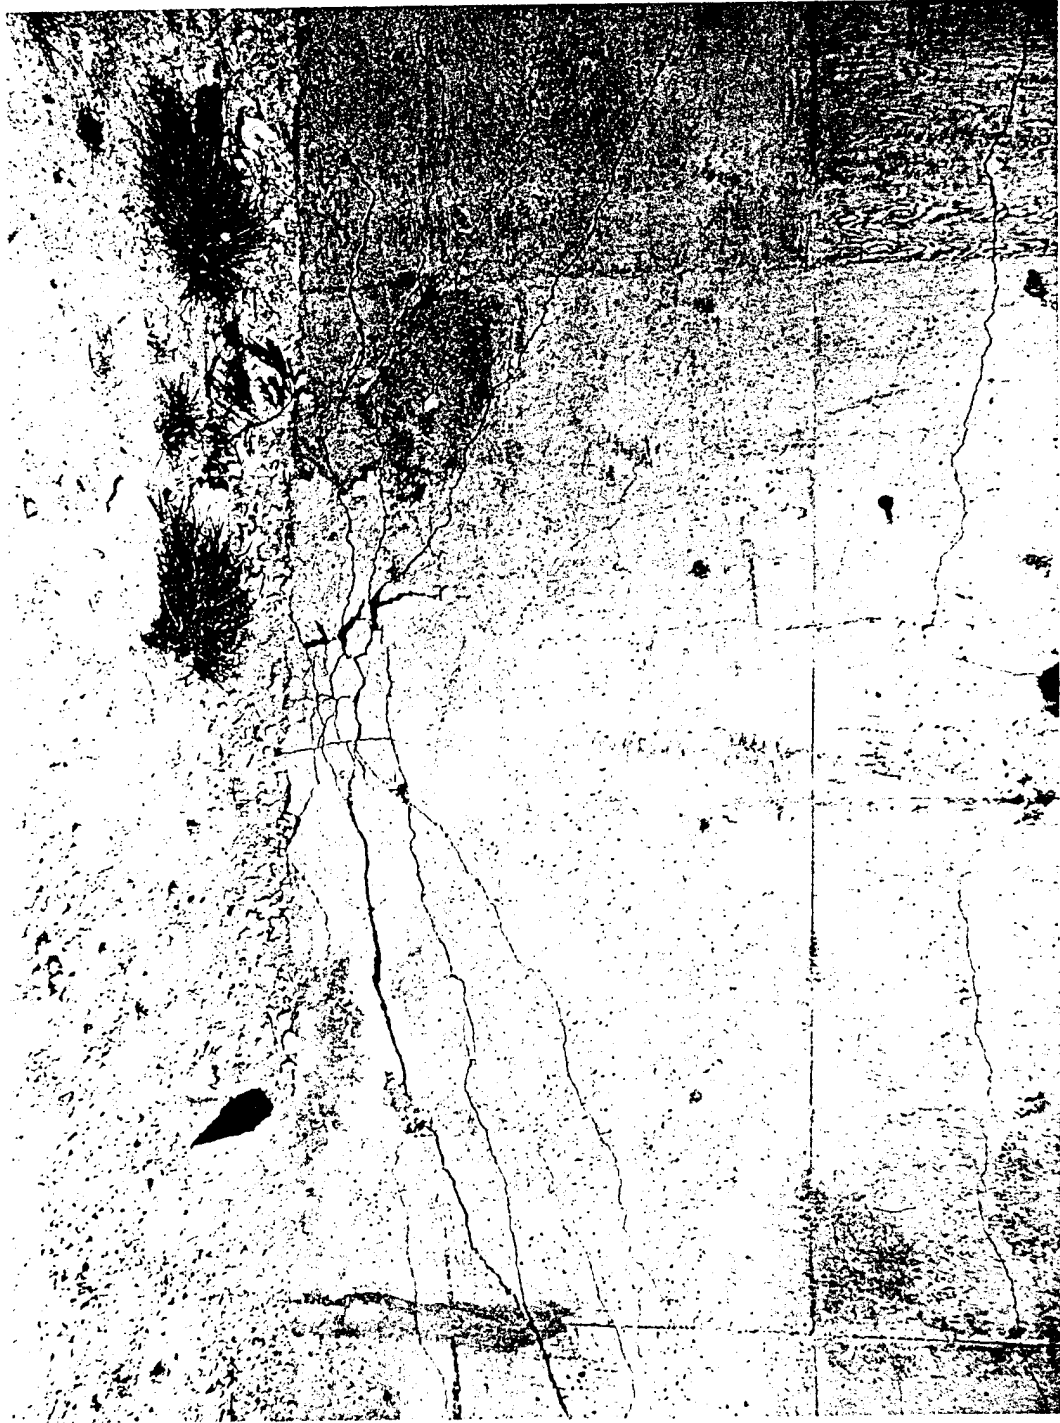
Fig. L. 473 Rear-column Failure at the Base Caused Rear-wall Cracks at Bottom Center, Structure 3. 2. 7a

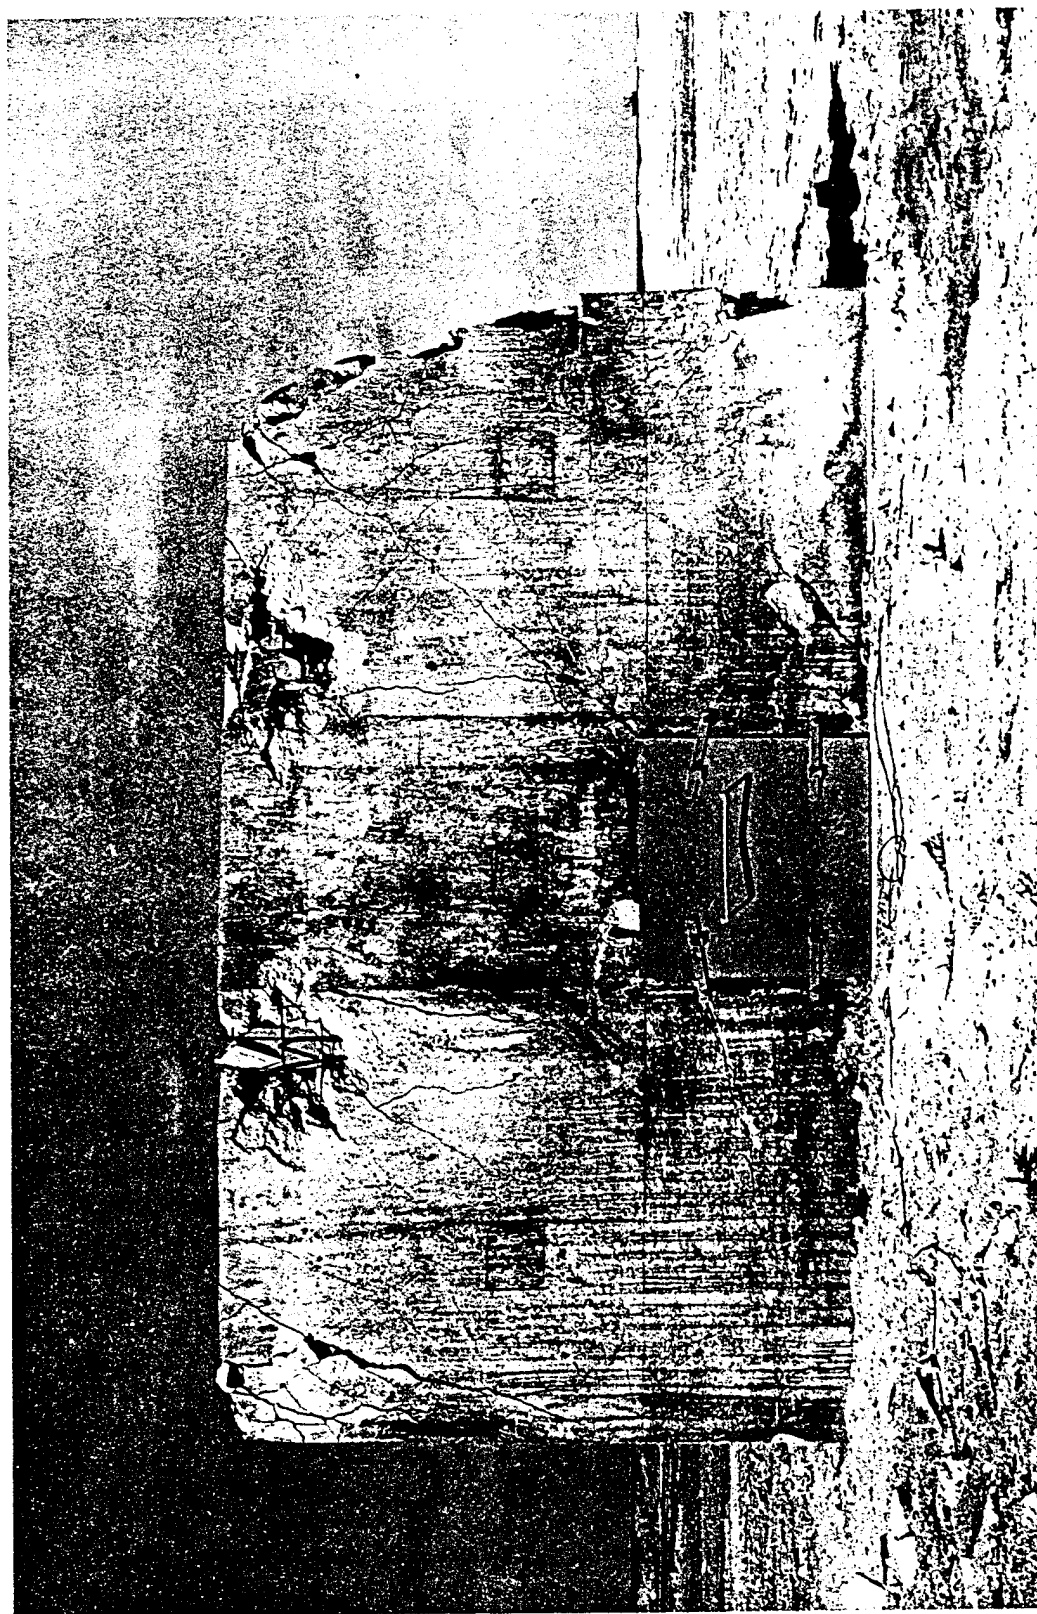
Fig. L.475 Left End Wall, Structure 3.2.7a

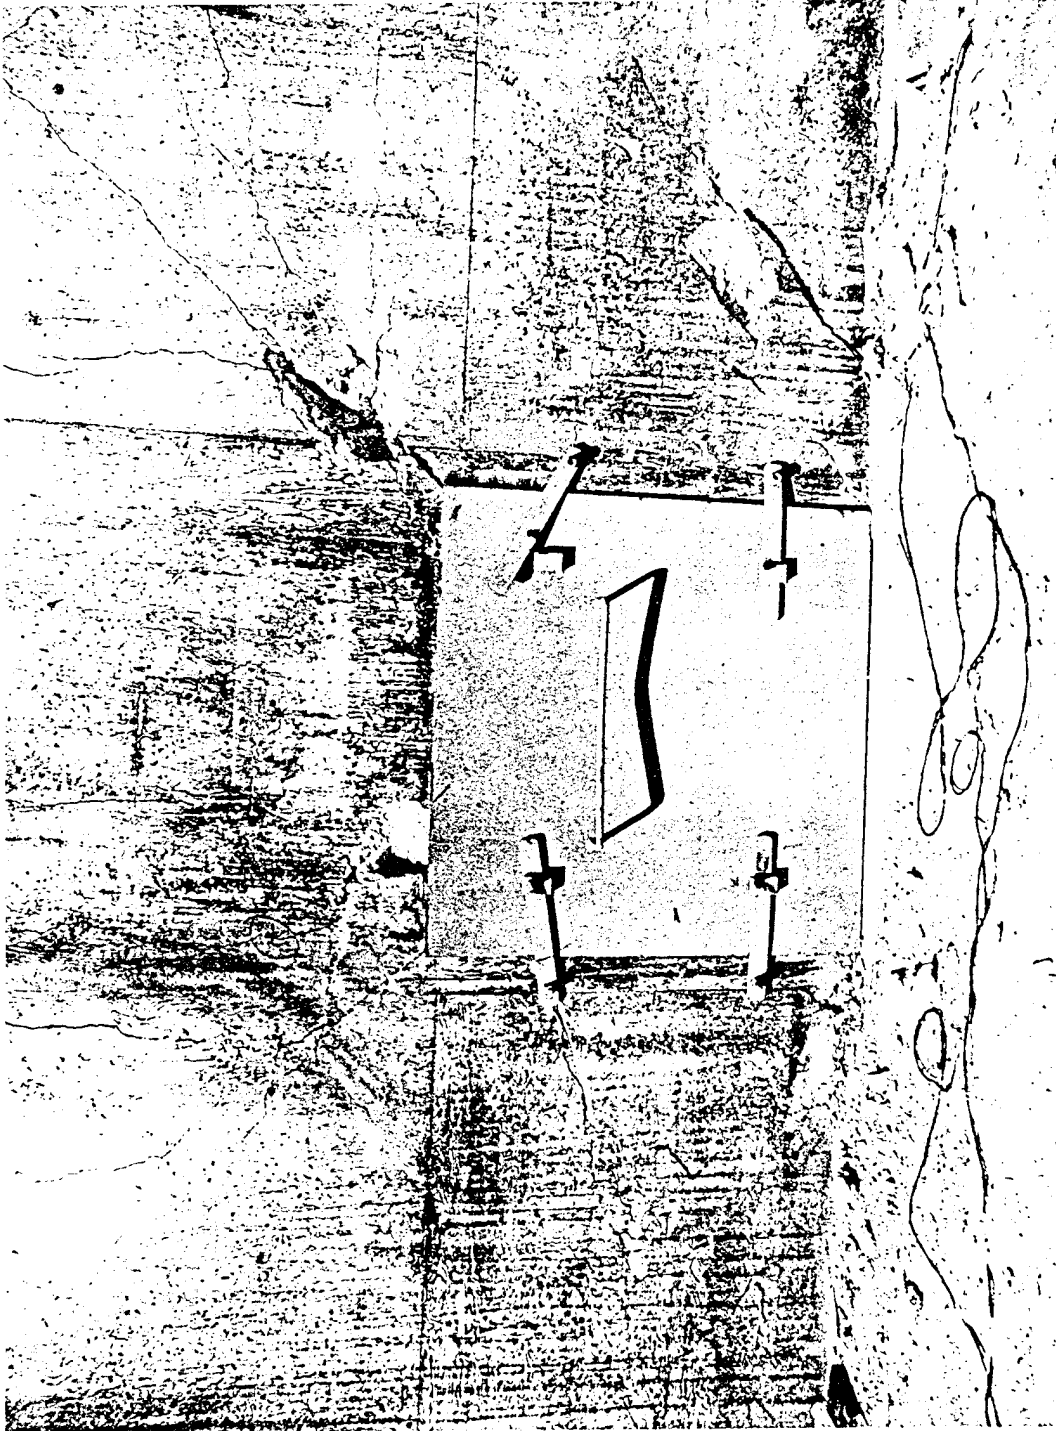
Fig. L. 476 Door in Left End Wall, Structure 3.2.7a. Cracks indicate concentration of stresses at upper corners of door caused by change in section. Cracks at bottom of wall are shear failures.

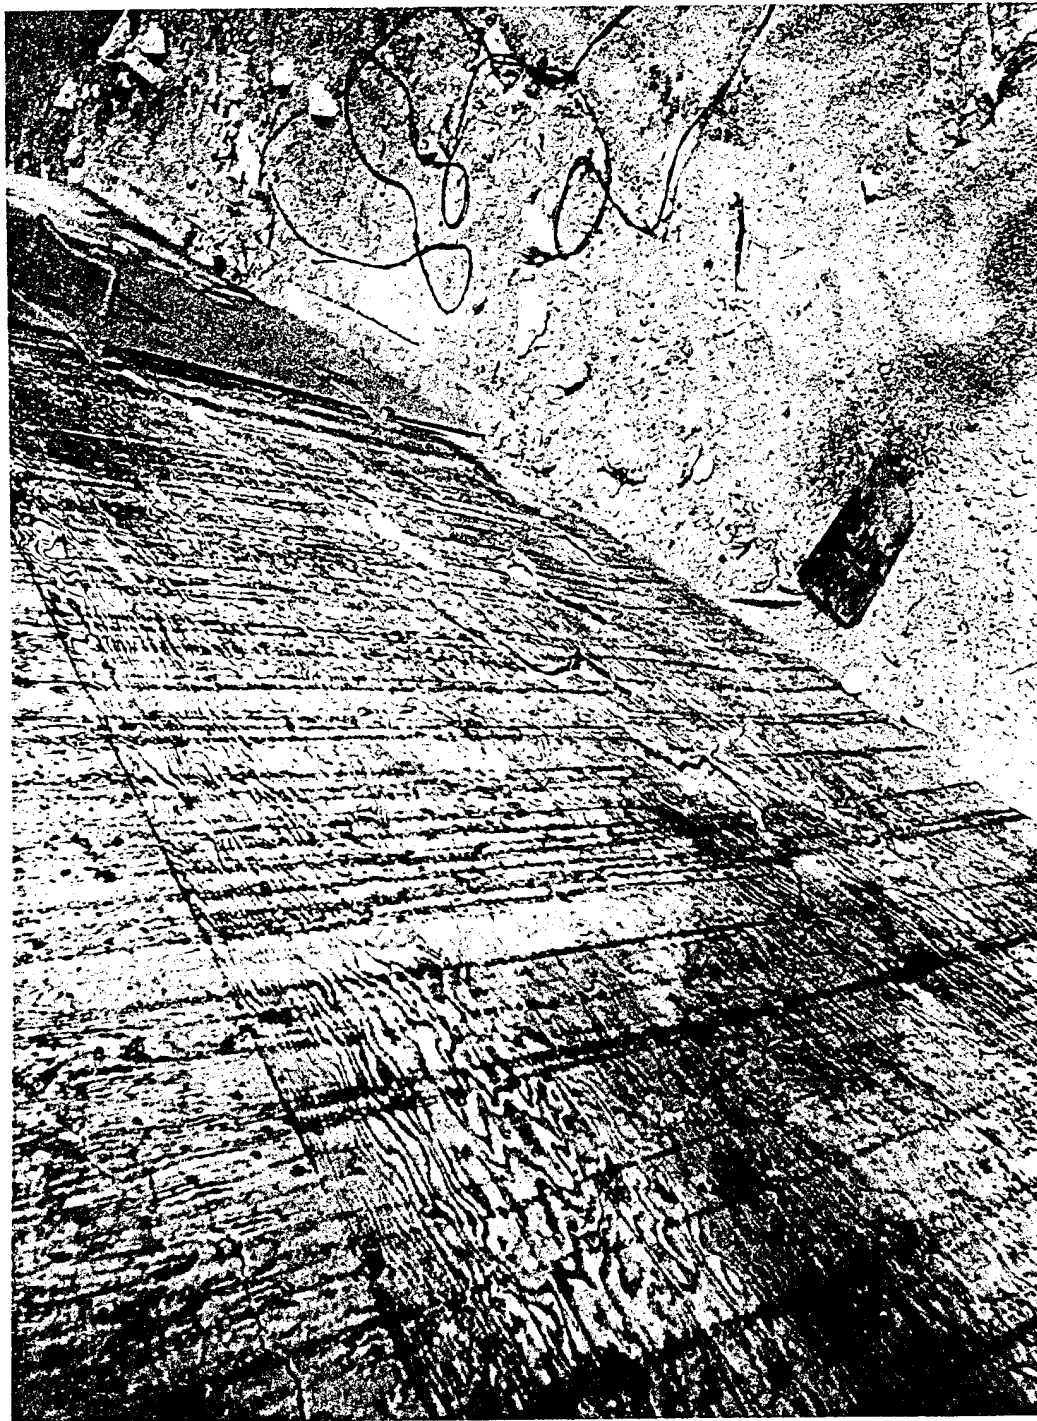
Fig. L. 477 Shear Cracks to Rear of Door, Structure 3. 2. 7a. Similar cracks were present on interior face.

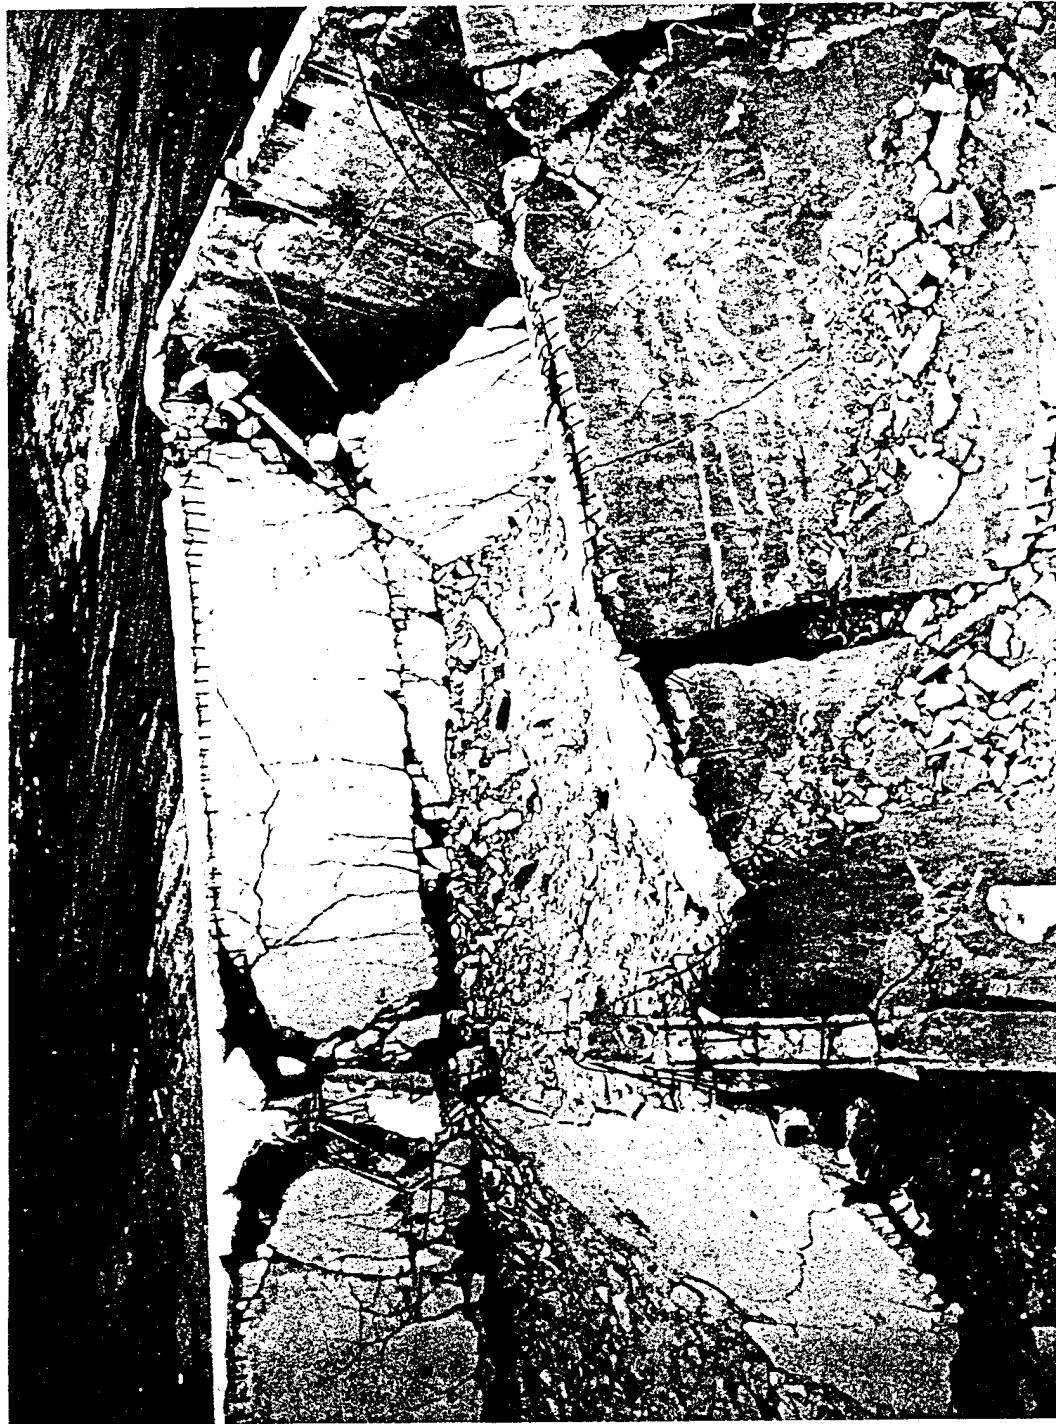
Fig. L. 481 Failure of Right Half of Roof, Structure 3. 2. 7a

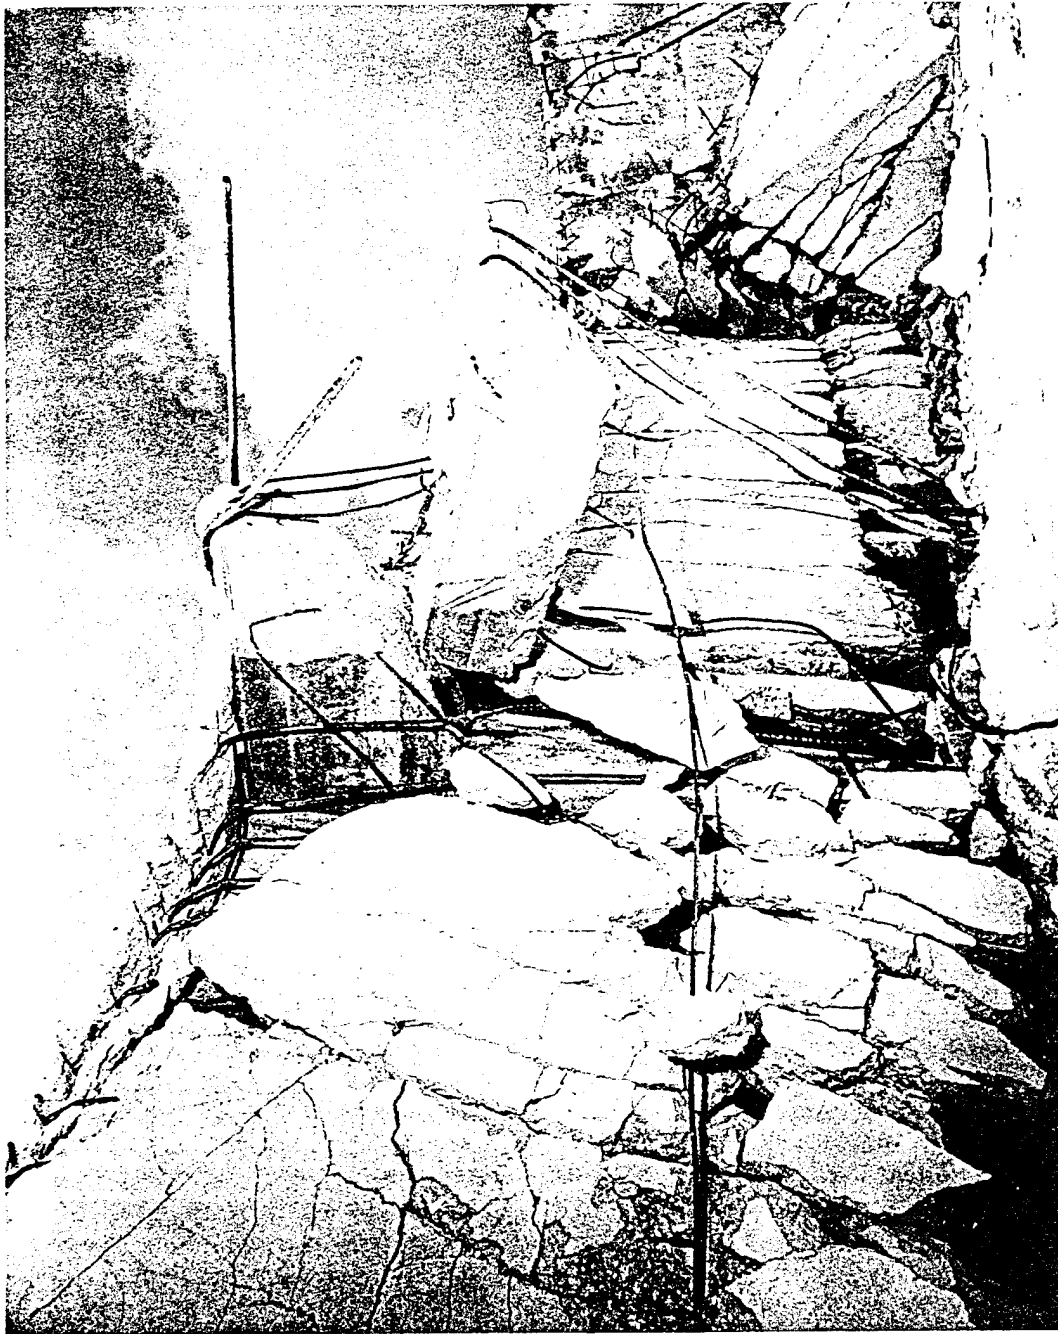
Fig. L.482 Diagonal Tension Failure of Girder near Rear Column, Structure 3.2.7a

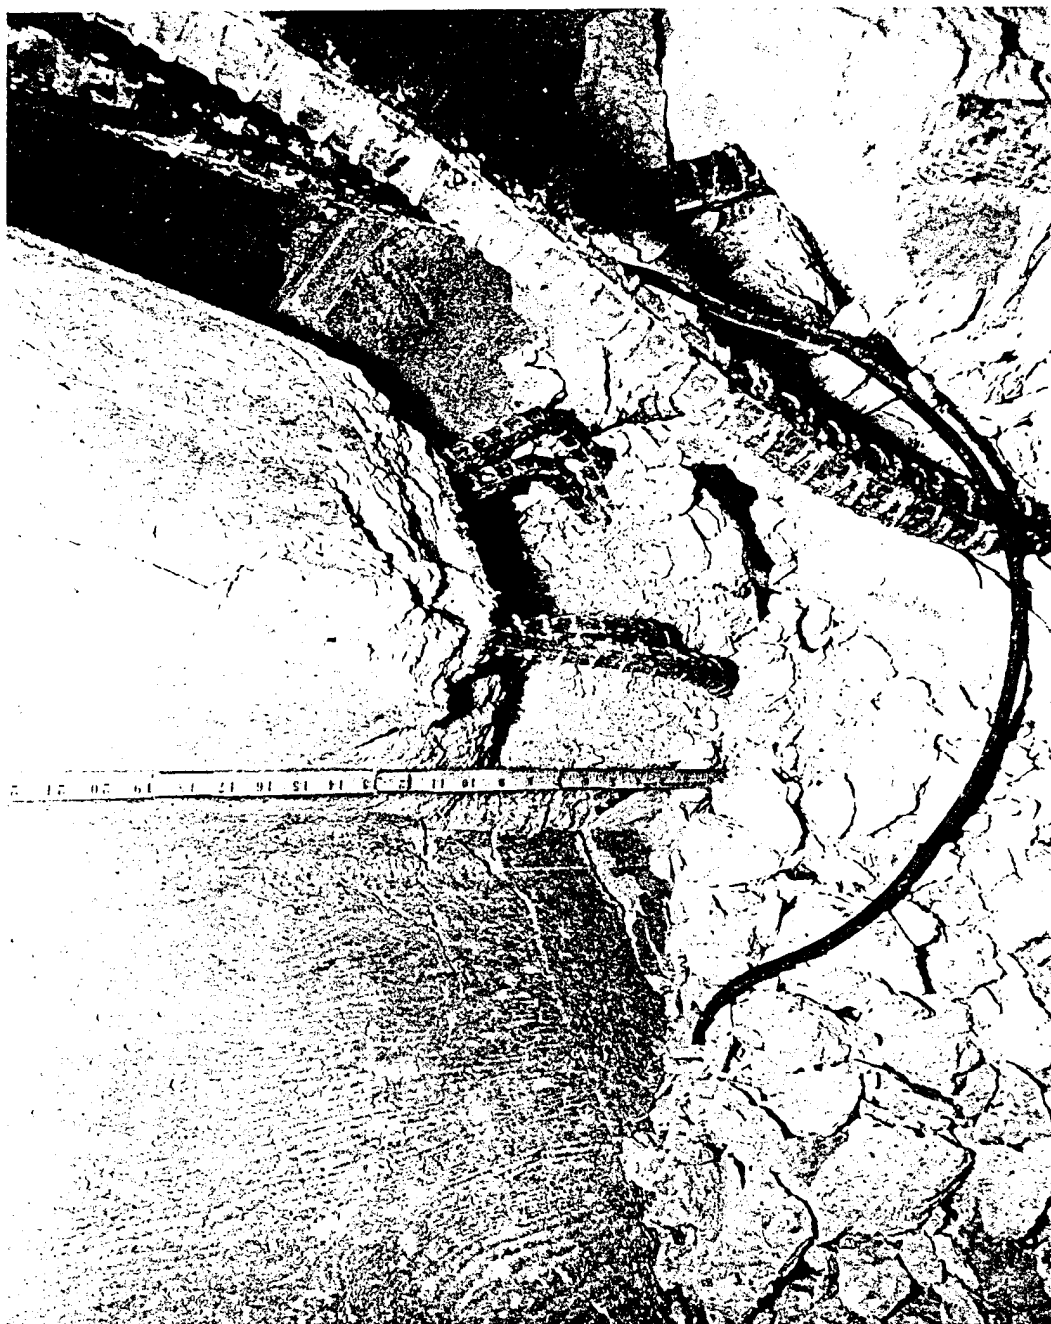
Fig. L. 483 Movement Failure at Base of Rear Column, Structure 3.2.7a. Girder steel in right foreground.

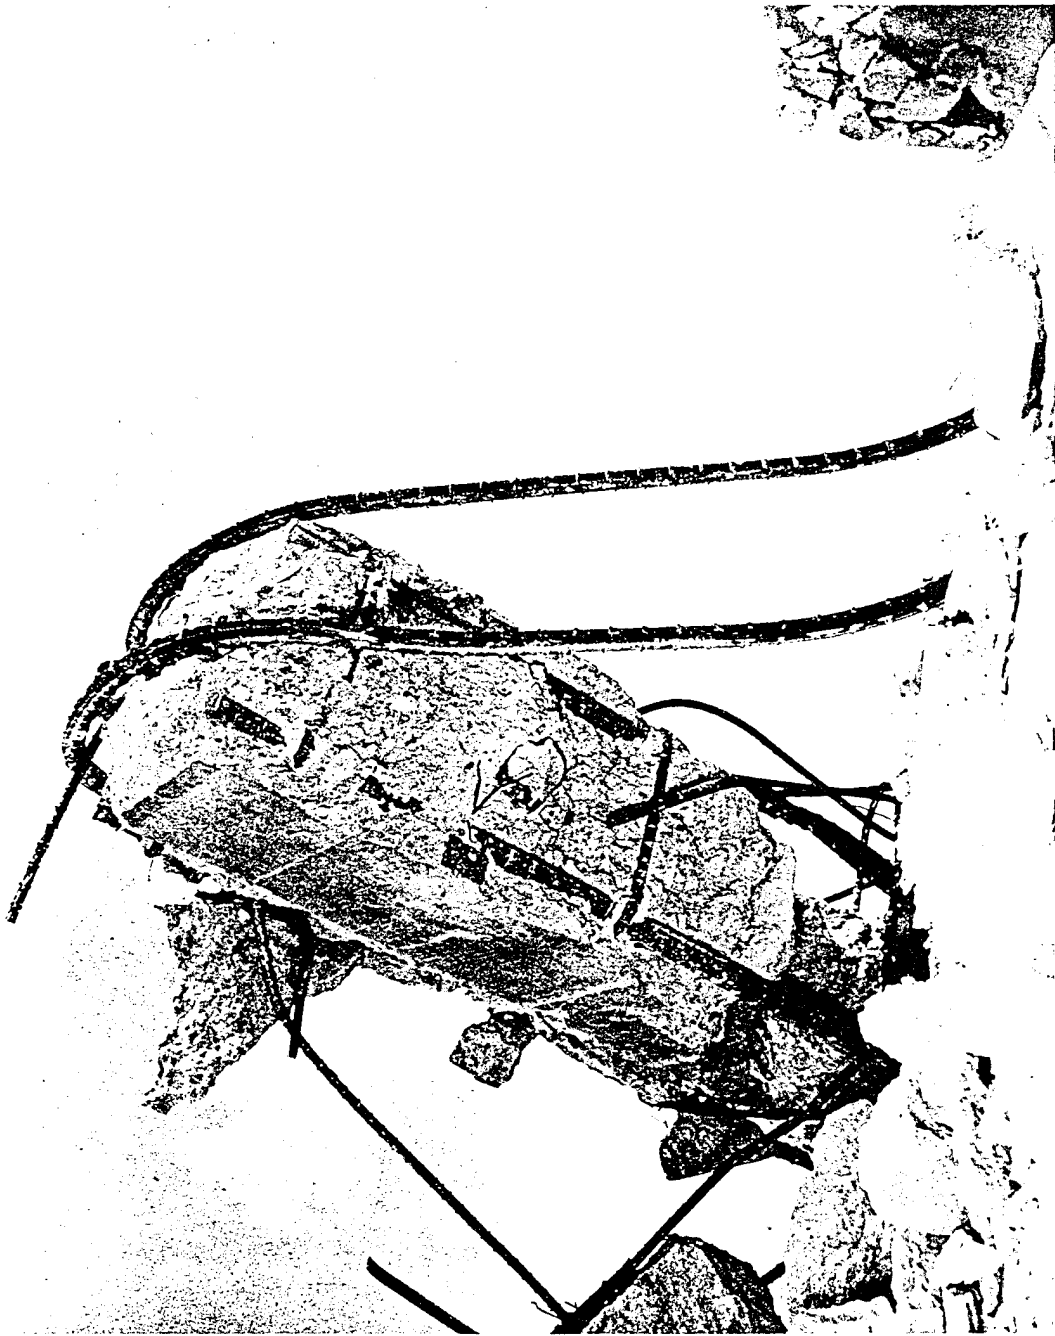
Fig. L. 484 Tension Failure of Girder Haunch at Front-column Face, Structure 3.2.7a

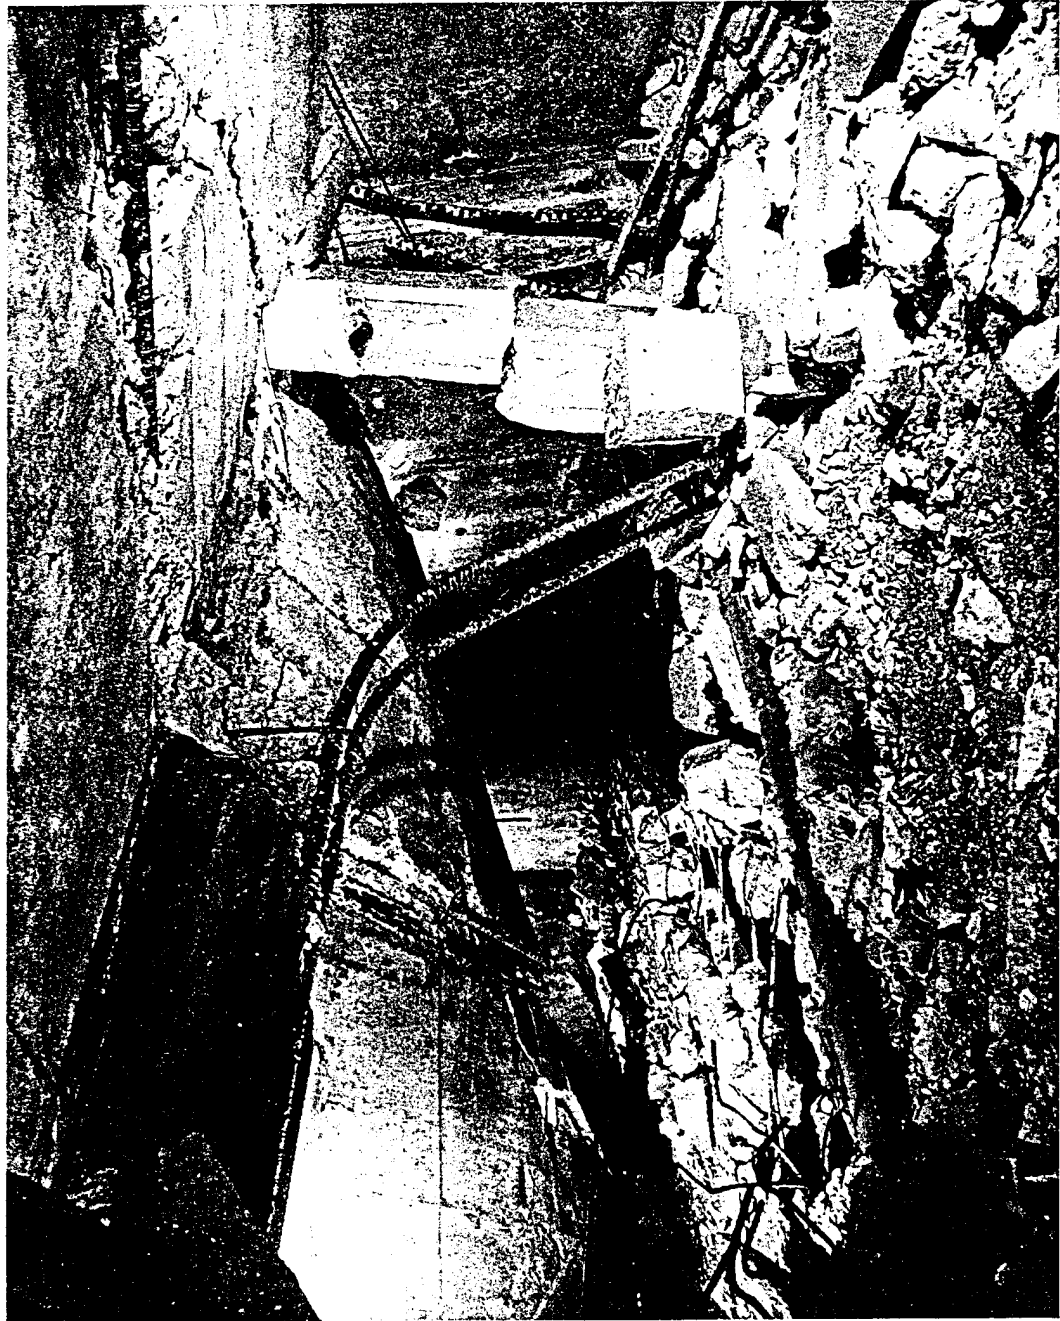
Fig. L. 485 Girder Failure Showing Bare United Bottom Tension Steel, Structure 3.2.7a

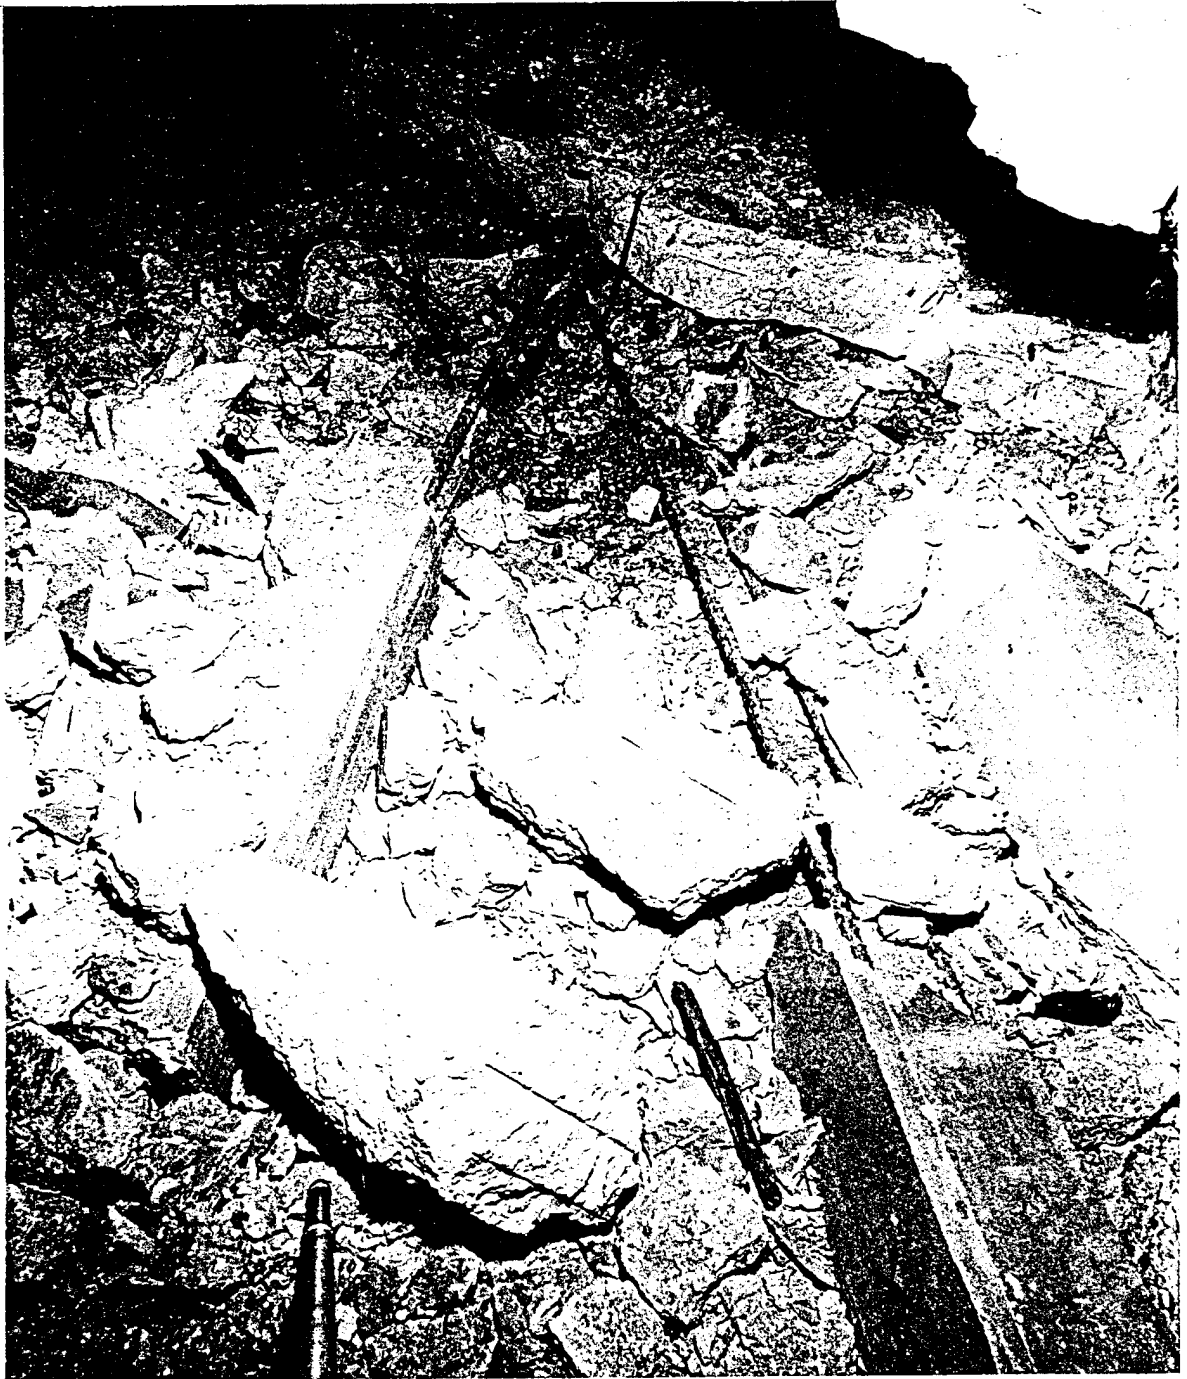
Fig. L.487 Untied Bottom Tension Steel of Stringers, Structure 3.2.7a

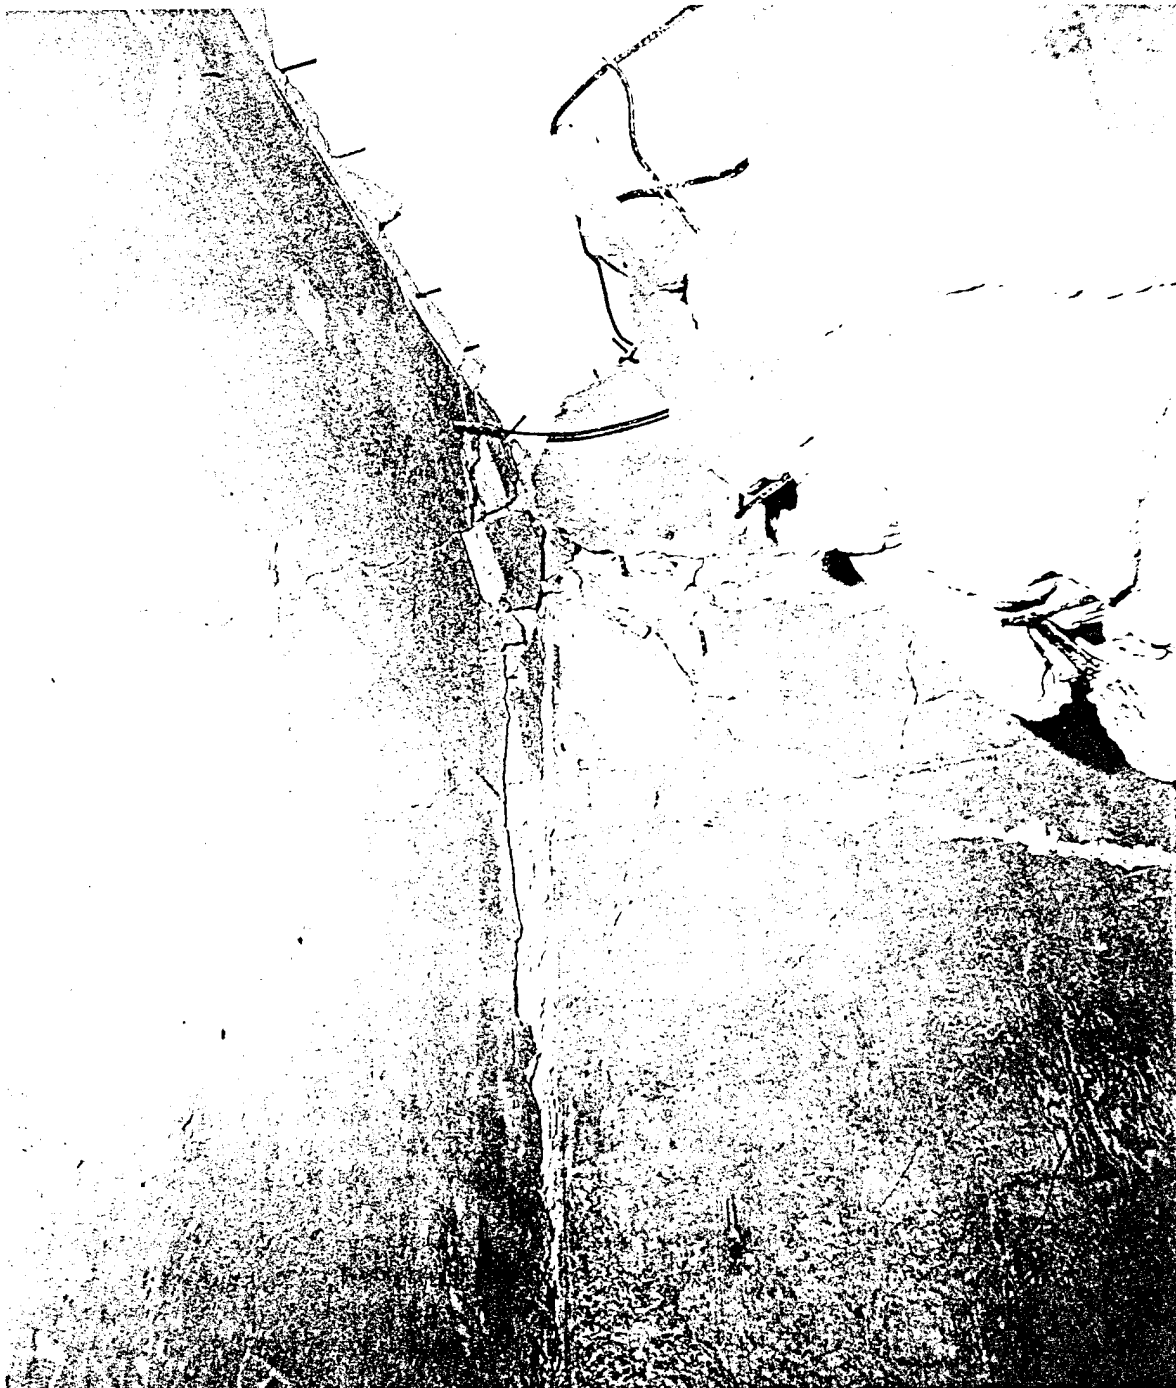
Fig. L.488 Interior View of Left Rear Corner Showing Roof to End-wall Bar Hooks Pulled Free, Structure 3.2.7a

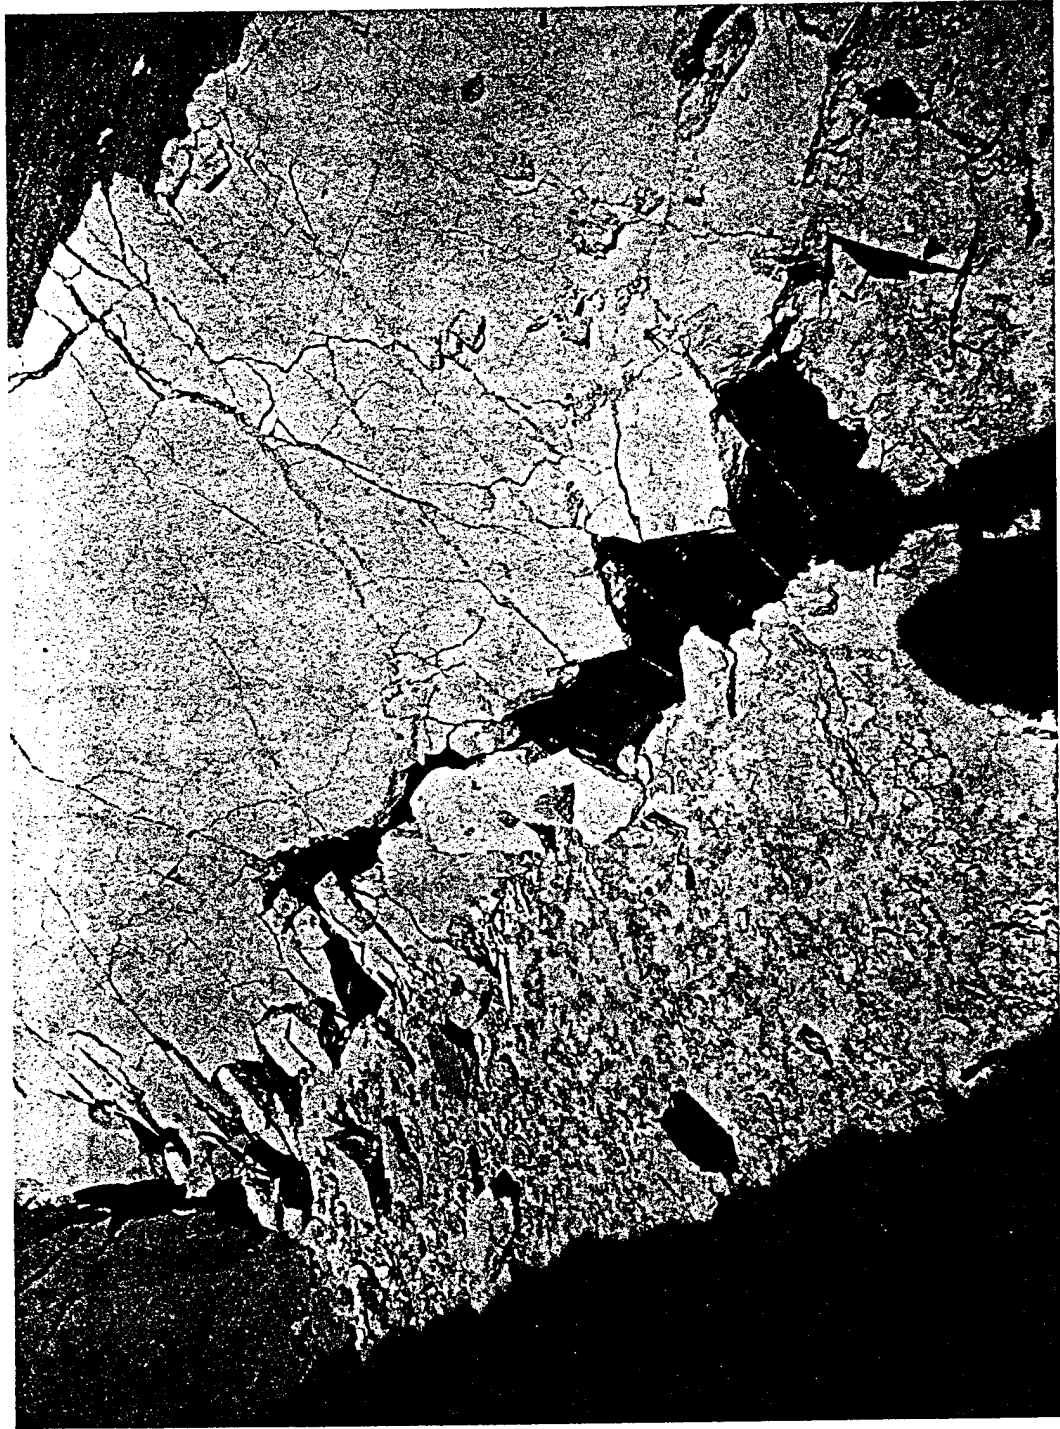
Fig. L. 489 Roof Failure along Front Longitudinal Stringer Line, Structure 3. 2. 7a
